UI Bulletin #159

Subject:	Cap-less Fuel Cover
Models Years Affected:	2017 - 2019
Models Affected:	Chevrolet Silverado (old body style) GMC Sierra (old body style) With Cap-less Fuel Fill and Gasoline Engines
Origination Date:	September 4, 2019
Revision Date:	N/A

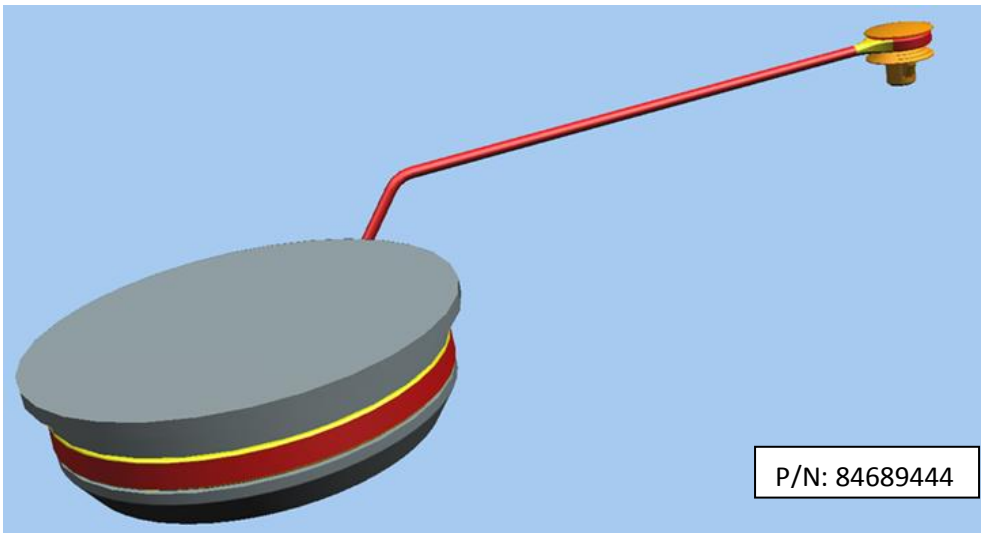
Figure 1

Some customer/vehicle operators may express a concern that dirt, dust and other contaminates have a potential of entering the fuel filler/tank due to contaminants making their way past the seals on the cap less unit. This issue may occur on vehicles that predominately drive on unsealed or dirt roads. This issue occurs because the fill pocket is unsealed near the hinge, and the fill pocket door is also unsealed.

Adding a tethered cap that covers the cap-less unit preventing contaminates from settling on the outer sealing door of the cap less unit. Refer to Additional Information for an illustration (Figure 1) and the part number of the tethered cap.
